# Manhole Inspection Summary

Manhole # S49EE\_028MH

Insp Date: **7/16/08 8:59 AM**

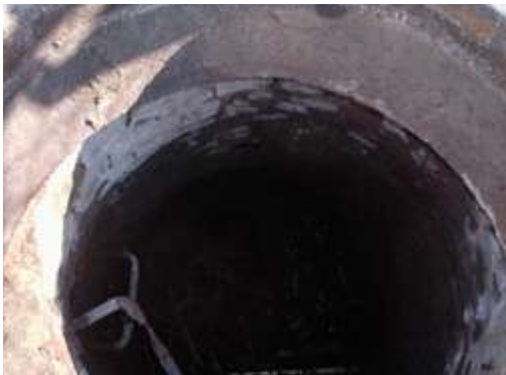
Defect 2

frame leaks

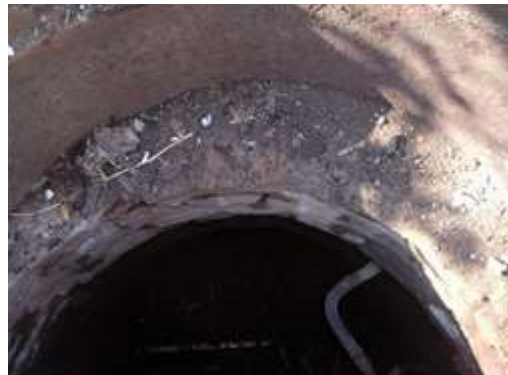
Defect 1

Infiltration: ☐ None ☒ **Joint** ☐ Cracks ☐ Mortar ☐ Roots ☐ Wall

Infiltration: ☐ None ☐ Joint ☐ Cracks ☐ Mortar ☐ Roots ☒ **Wall**

infiltration

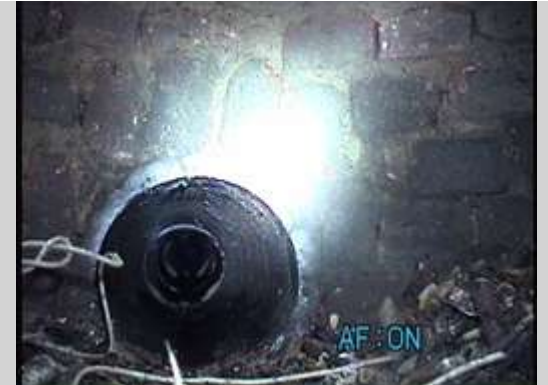
12 O'Clock Outflow

8 in. Circular Gravity Sewer  
Pipe Out @ 12 O'Clock

Infiltration: **None** Pipe Seal Cond: **Sound**
